Addressing water-hammer events on equipment and concrete flooring infrastructure

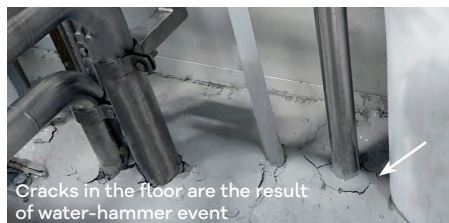
Wireless IoT acoustic sensors were used to monitor an entire processing area for water-hammer events. By detecting high amplitude events and characterising the acoustic profile by its frequency and acoustic pattern, it allowed for water-hammer events to be detected while ignoring other 'loud' events that can be attributed to normal operating procedures.

ThingWave IoT vibration sensors were then installed as required on suspected pipework to give a precise confirmation as to the exact pipework experiencing the water-hammer impact and the exact timing of these events.

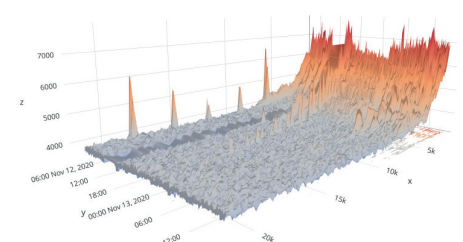
The baseline vibration data indicative of water-hammer was measured (see below), collected, and plotted against the manufacturing's operational sequence timestamps (Unix timestamps) using ThingWave's in-house programs. By engaging with the client's Automation team, the data timestamps and SME, individual equipment (valves/pumps/etc) engaged at that point in which the water hammer was observed were identified.

Vibrational figure print of water-hammer impact events

The client has since updated the parameters within the identified automated sequences responsible for each of the water-hammer events, thus eliminating all future events and on-going damage to the facilities equipment and floor infrastructure.
